## ENVIRONMENTAL TEST REPORT

AMICA Star Tracker (AST) - QM Model

INFN Roma – CARSO Trieste

The AST qualification model has been tested at S.E.R.M.S. in the Thermal Vacuum Chamber (TVC) during the period July 7<sup>th</sup> – 10<sup>th</sup> 2006 (**thermal balance test**).

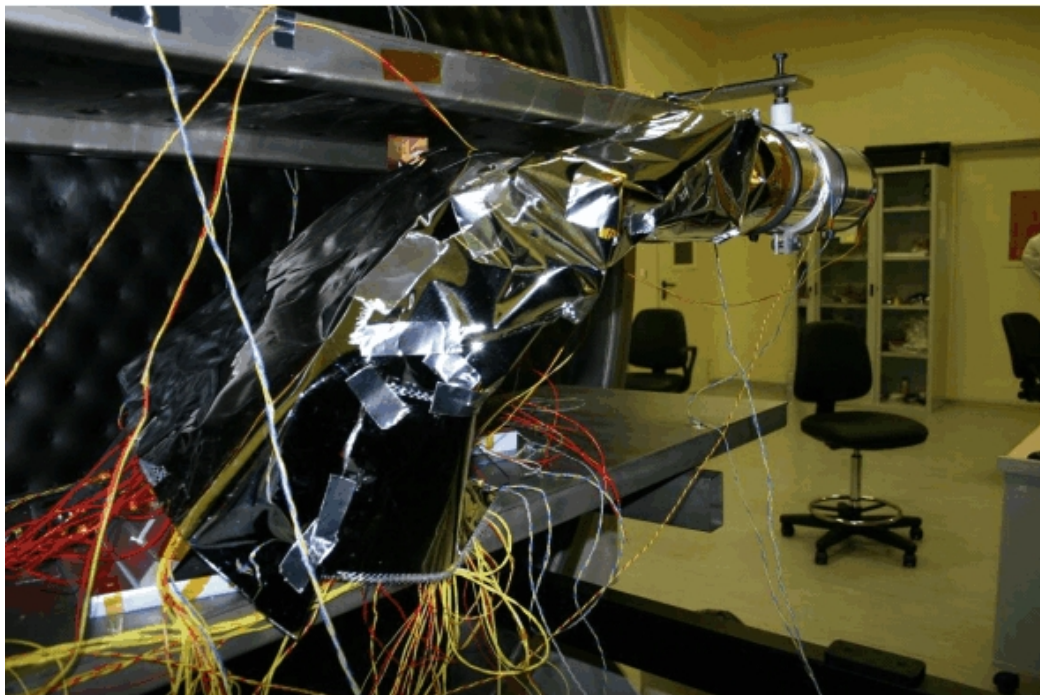
FIGURE 5 - TEST SET UP (WITH MLI).

Some variations have been done regarding the position of the MLI.

- As foreseen in the customer procedure: the MLI should wrap separately the CTA (Copper Thermal Arm) bar, fixture and AST;  
As it was during the test: the MLI wrapped both CTA (Copper Thermal Arm) bar, fixture and AST to avoid Pt100 wires pulling and because there was not enough space between the CTA bar and the AST.
- As foreseen in the customer procedure: the MLI should be fixed between the first ring and the second ring of lens fixture;  
As it was during the test: The MLI of the AST has been fixed on the Aluminium collar.
- As foreseen in the customer procedure: the MLI should be fixed on the third ring of the lens fixture;  
As it was during the test: The MLI between AST and baffle has been fixed between the second ring and the third ring of the lens fixture.

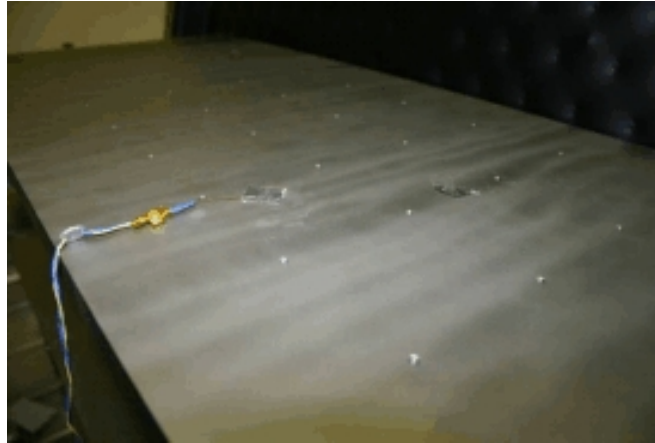
FIGURE 8 - COLD PLATE SENSOR 17: CP UPPER.

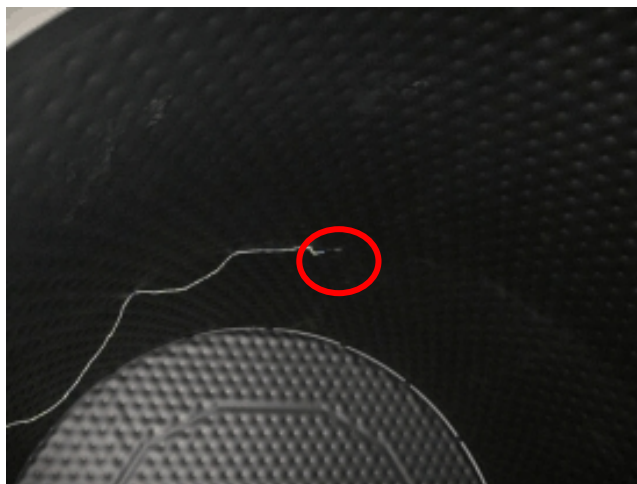
FIGURE 12 - CHAMBER SENSOR 4.

- 1 TS (naming scheme sensor 4) was placed on the shroud
- 6 TS were placed in different locations of the Cold Plates (CP).

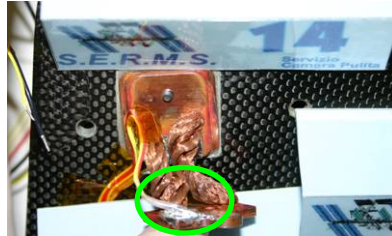
FIGURE 17 - EXTERNAL PT100 SENSORS (14 NI – 20 NI)

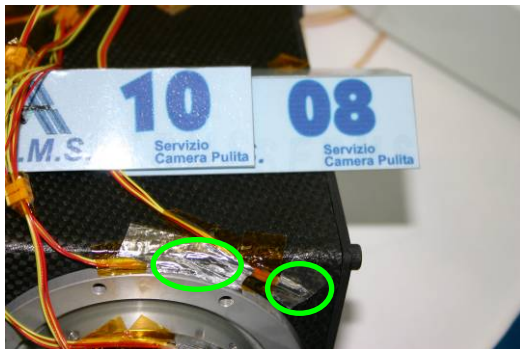
FIGURE 18 - EXTERNAL PT100 SENSORS (8 NI – 10 NI – 11 NI – 12 NI)

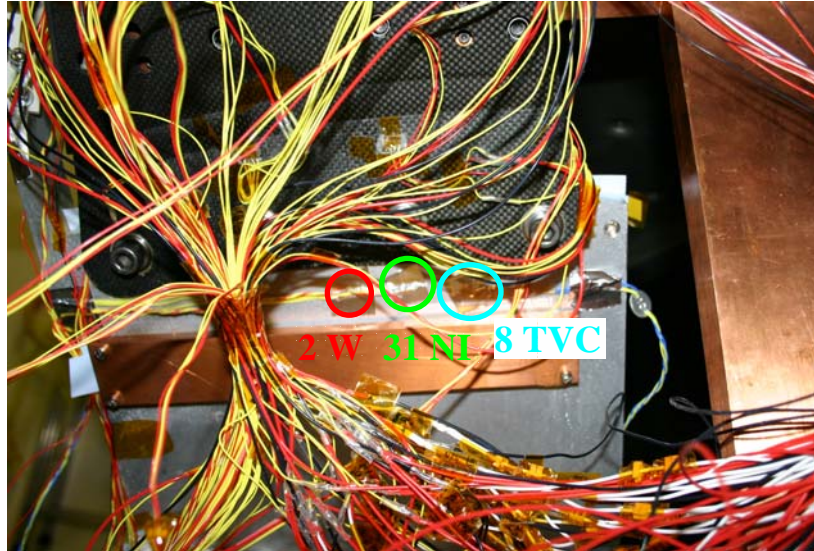
FIGURE 25 – THERMAL BALANCE FIXTURE (TRACKER I/F UPPER) THERMAL SENSORS  
(31 NI – 2 W – 8 TVC)

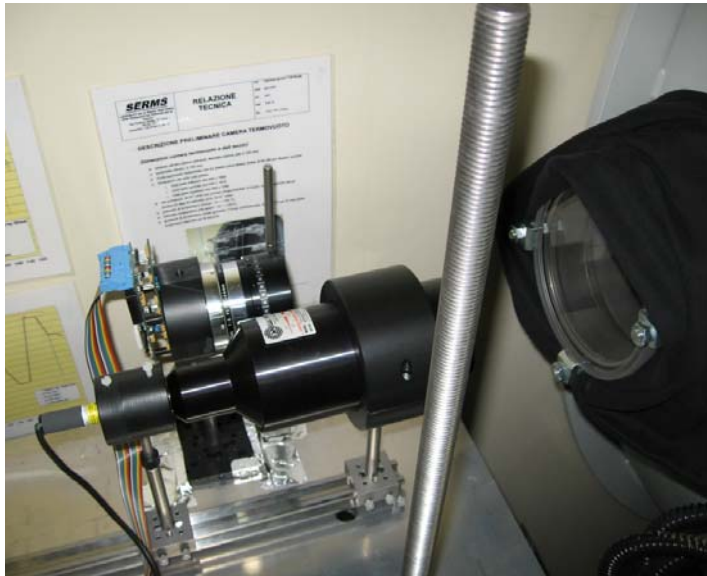
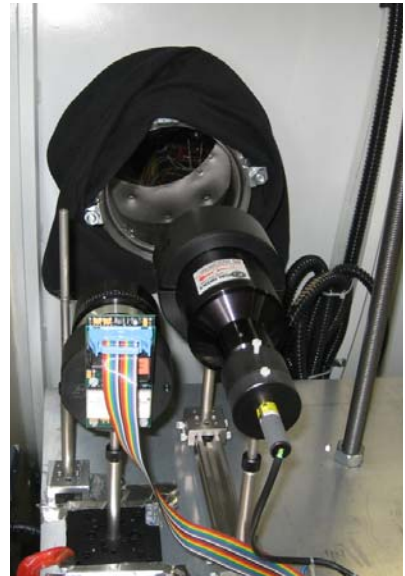
FIGURE 37 - EXTERNAL LASER AND CCD
